## **Mongoose Pro GMII Clone modification**

### The problem:

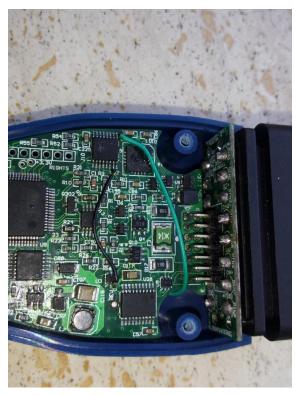
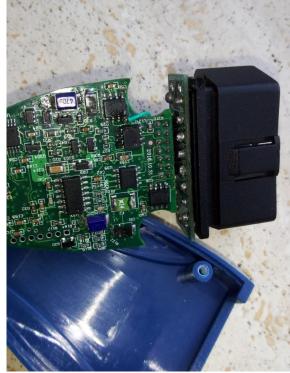
The Mongoose Pro GMII Clone with pcb rev. C (2016.10.31) has routing problem. The result of this is that SWCAN bus communication with the car via DLC pin 1 is not established. T2Win for example cannot communicate with SAAB I-bus.

If U52-7 is connected to u37-8 and U52-9 is connected to u3-3 it means that the outputs of the dual multiplexer (pin 7 and 9) are exchanged.

Rerouting u52-7 to u3-3 and U52-9 to u37-8 will give working device for T2Win.

After modification SWCAN from TH8056 is switched correctly from output pin u52-7 to buffer u3-3 via u3-4 to CAN controller u26, and High speed CAN transceiver u37 is correctly controlled via pin u37-8 by output u52-9.

I lifted u37-8 and u52-9 from the pcb so that the pins are free from the pcb. Then with thin wire connected u37-8 to u52-9 and a wire from U52-7 to u3-3. See the pictures.
